## ICE BUOY DEMONSTRATION PROGRAM

Kenneth R. Bitting

June 1975

Final Report

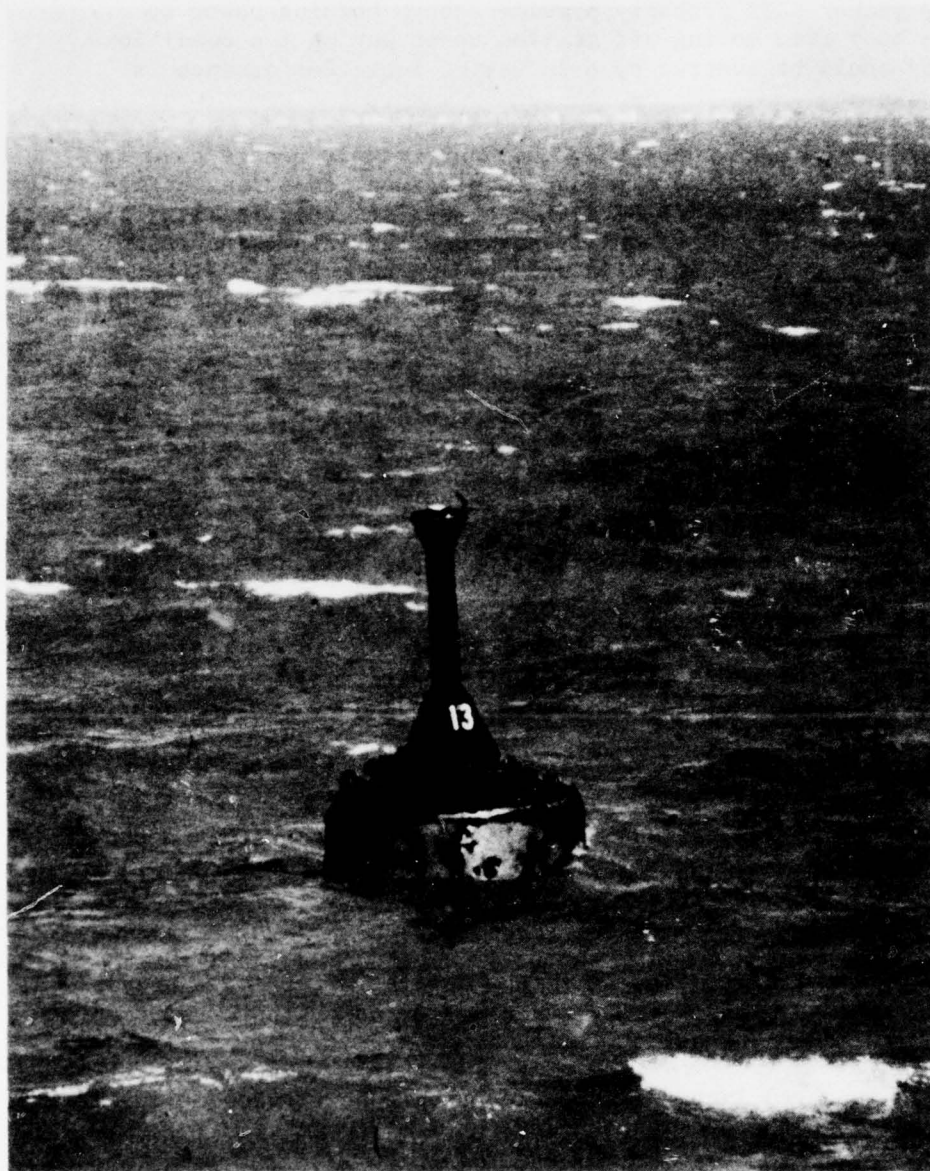
These buoys are submerged by eight to ten inches of moving ice. Lanterns are generally lost (Figure 1), and the battery pockets have been ripped open and flooded on occasion (Figure 2). On some areas of the hull, paint was scraped off to the primer or bare metal. Reports from mariners indicate that the buoy can be more difficult to identify if the ice scrapes off the red paint and reveals the dark primer. The characteristic color, therefore, changes. The deep hull of the 9x32 ice buoy presents a large vertical surface to the ice. As the ice pressure increases, the buoy lays over and the hull submerges until just the lantern and pole are above the ice (Figure 3). In thin ice (six to eight inches thick) this appears to be the stable position. In thicker ice (eight to ten inches) the ice force on the hull is too great and the pole and lantern go under the ice. The advantage of the 9x32 and 9x38 buoys is a large reserve buoyancy (16,000 pounds).

Figure 1. 9x32 ice buoy with lantern and paint damage  
(Lake St. Clair LB13 - FY74).

(5) Improved lantern protection should be provided to eliminate lantern damage when the buoy goes under the ice.

(7) The buoy hull paint primer should be the same color as the paint.

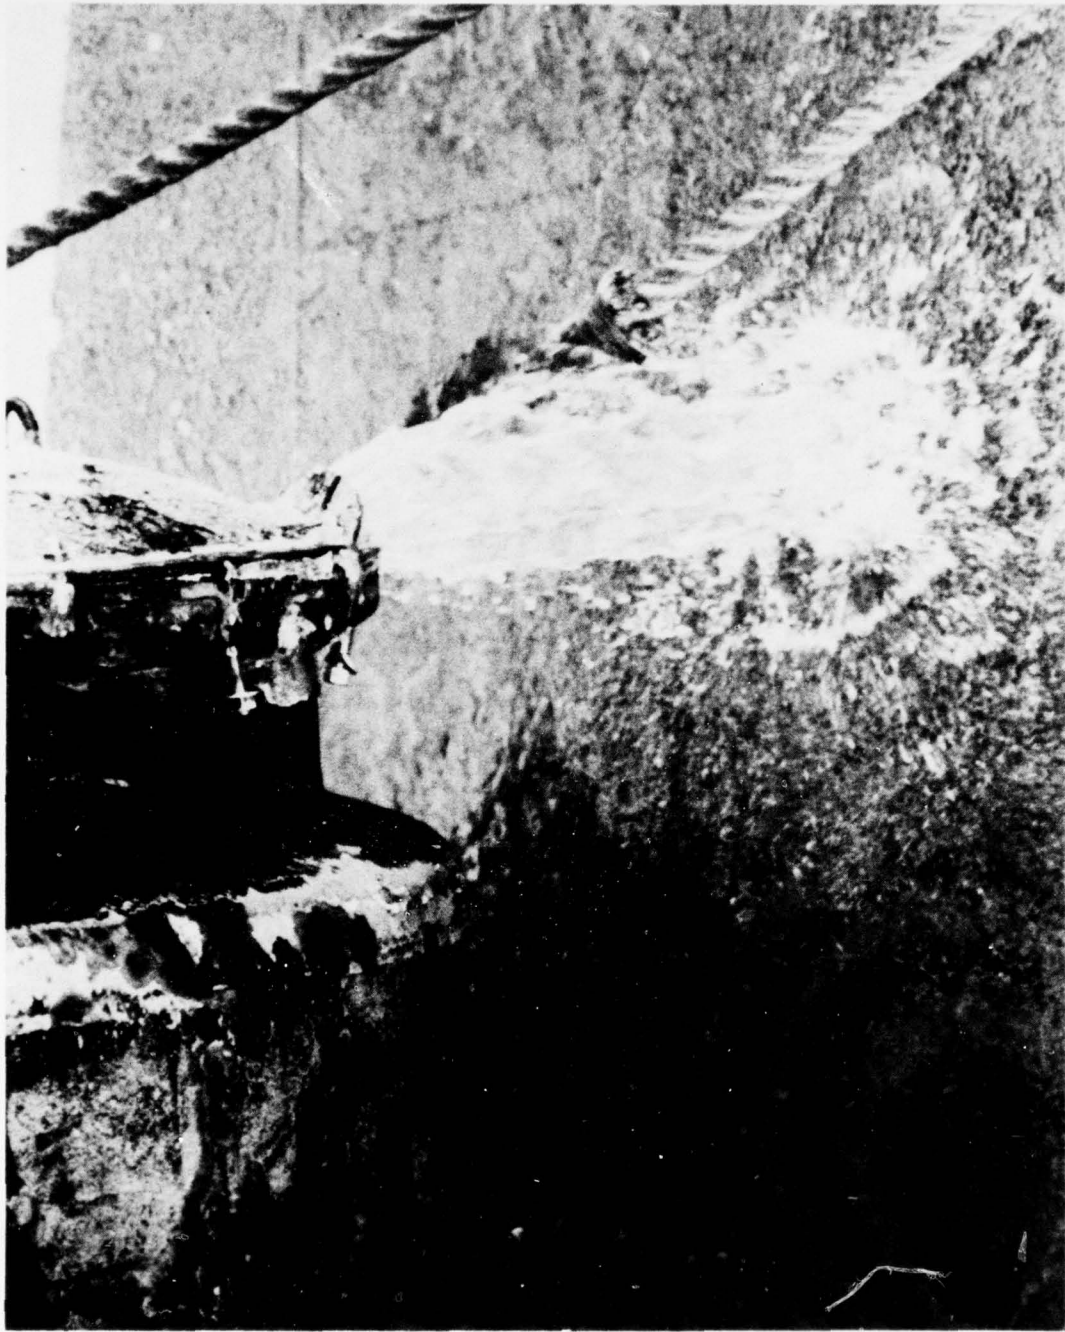
Figure 2. Battery pocket damage on 9x32 ice buoy  
(East Outer Channel LB1 - FY74).

(6) Battery pocket covers should be made flush with the hull if practicable.

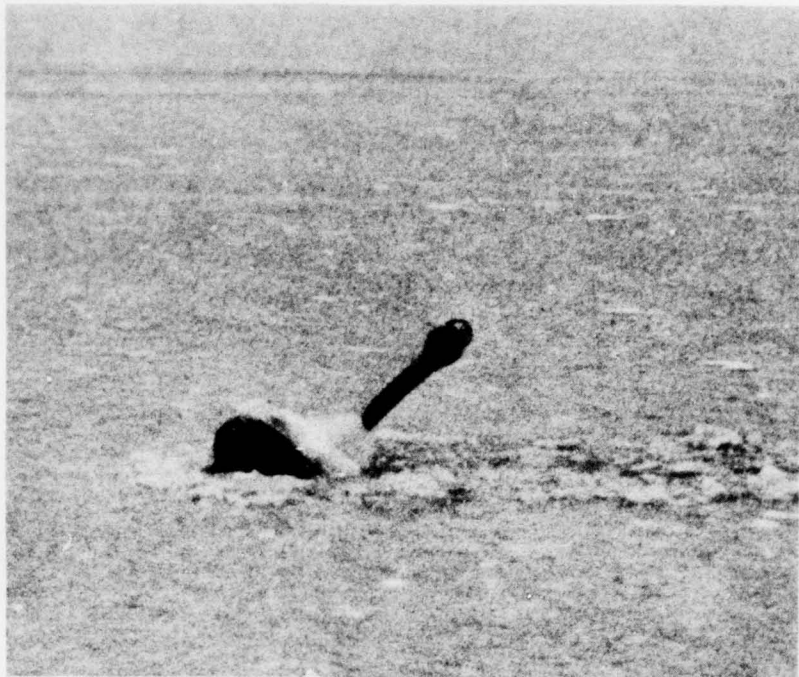
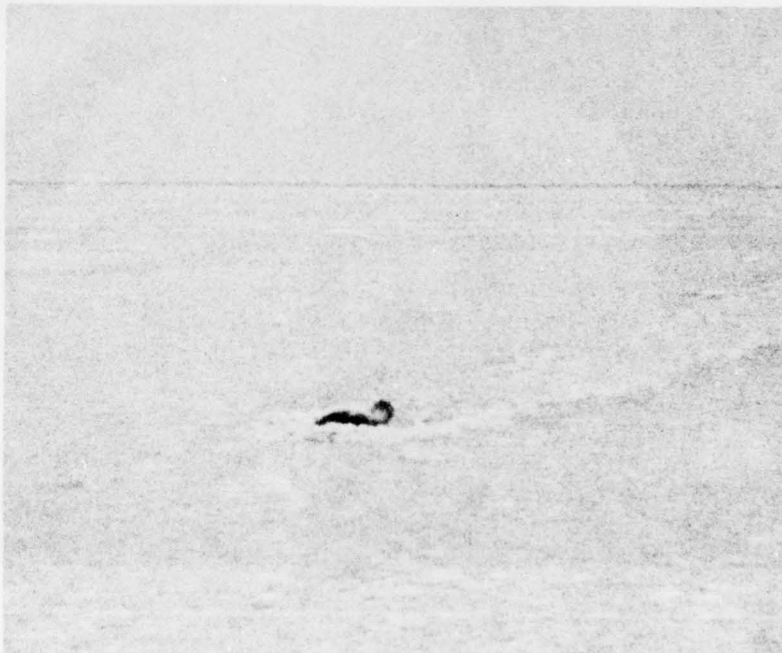
Photographs indicate that the 9x20 is overrun by ice that is approximately six inches thick. It appears to lack the ballast to compensate for the ice force on the hull. Figure 4(a) shows a 9x20 as photographed when it was abeam of a ship that was moving parallel to the ice flow. The buoy is listing approximately 45°. In Figure 4(b), looking back at the buoy after the ship passed, the buoy appears to be on its side. In a third frame (not shown), the buoy has disappeared and only the wake is visible. In Figure 5, ice has filled the lantern cage and snow covers the entire deck. A subsequent photo (not shown) shows the lantern destroyed but the cage undamaged.

Figure 4. 9x20 ice buoy under ice.

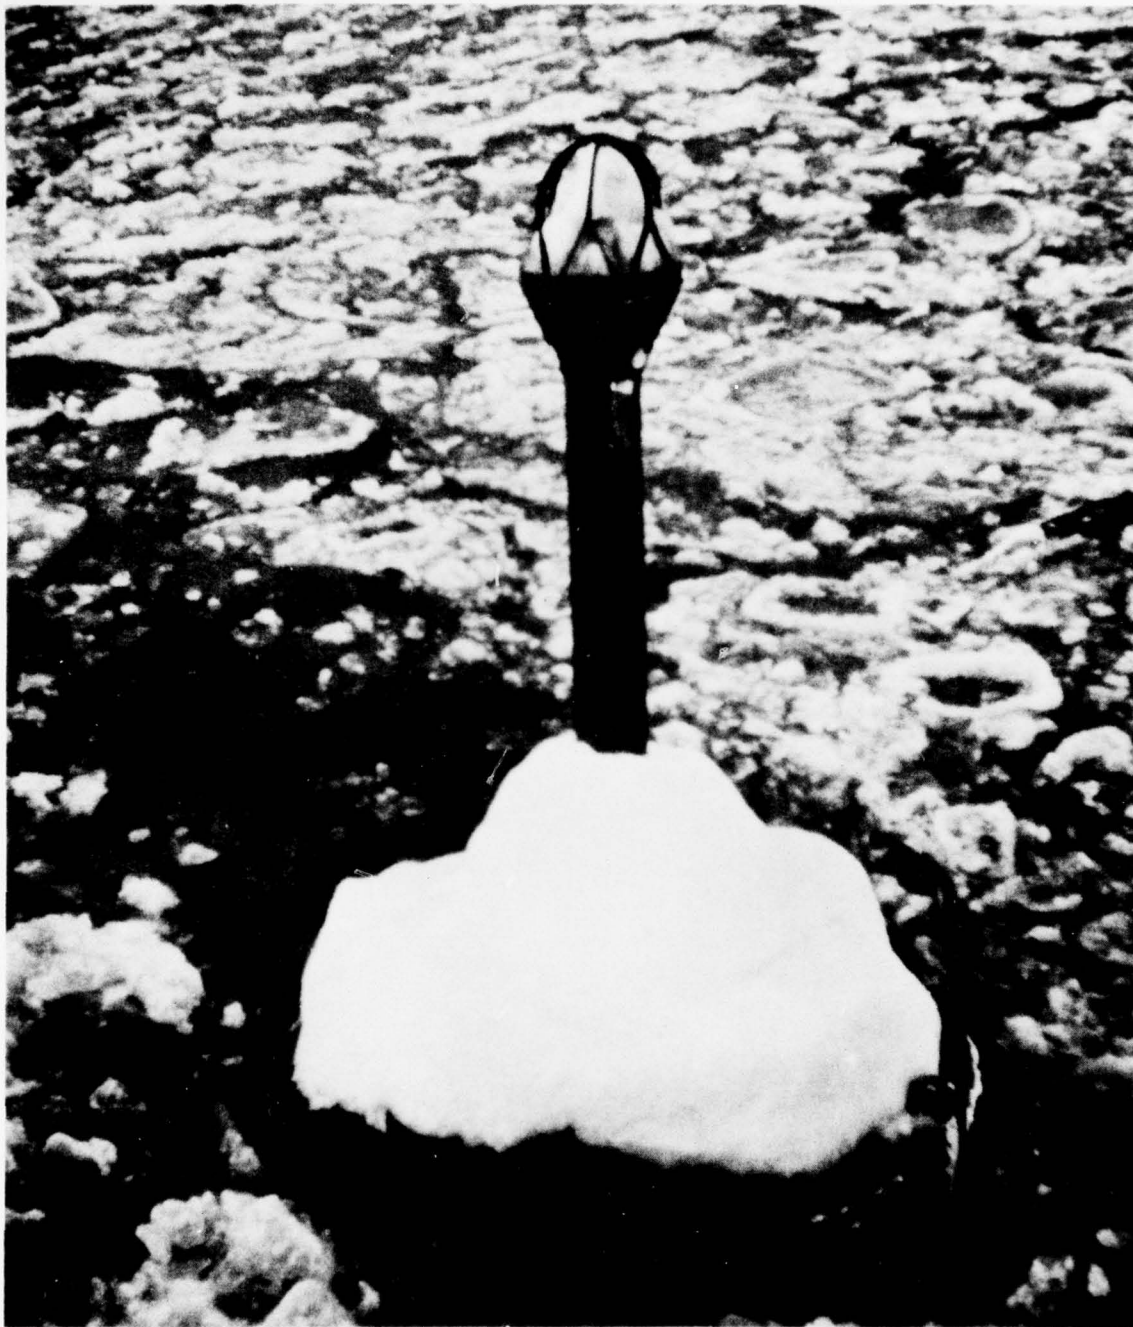
Figure 5. 9x20 ice buoy with ice in lantern case.

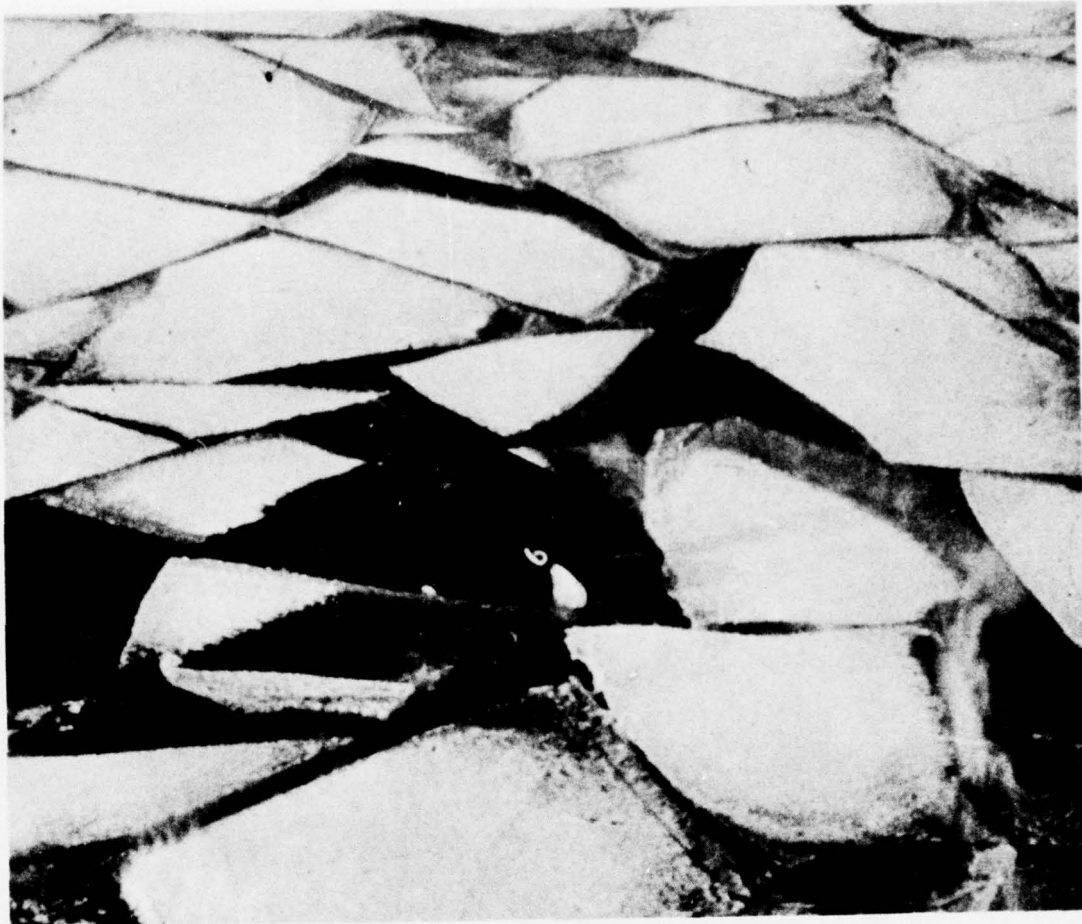
Before ice forms on the river, 5x18 buoys have been observed floating horizontally with large quantities of spray ice on the upper portion (Figure 6). The 5x18 is submerged by four to six inches of ice (Figure 7), and the lantern is generally broken. It has been observed upright in as much as fourteen inches of ice, however. One buoy was under the ice in the St. Lawrence Seaway for 45 days and was functioning upon recovery.

Figure 7. 5x18 ice buoy in 6 inches of moving ice.

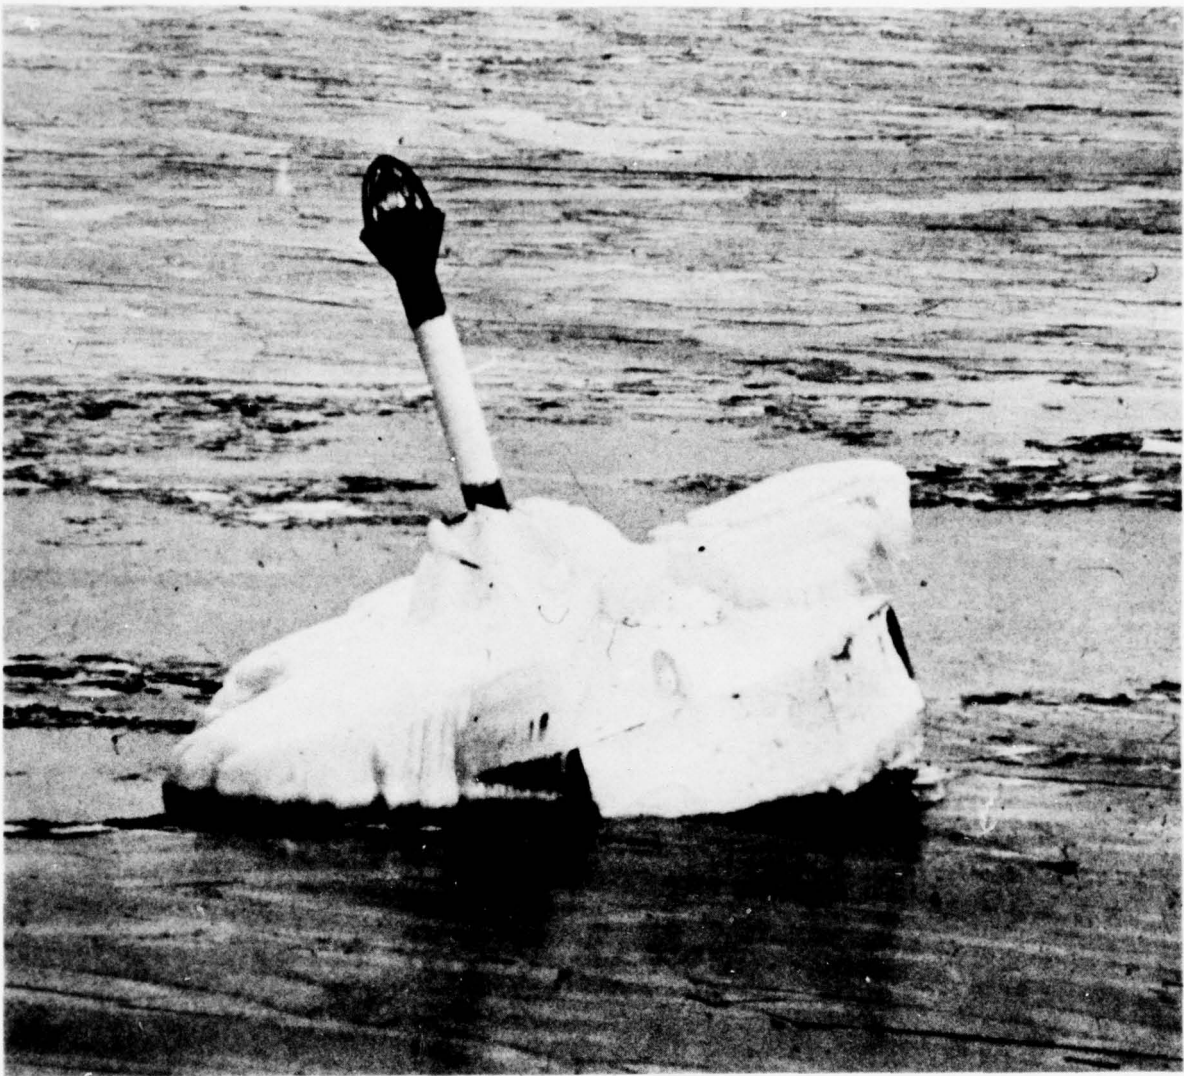
During FY73 and FY74, this buoy was deployed in locations where moderate ice conditions were encountered. Approximately twelve inches of ice and snow collected on the deck causing the buoy to list approximately 15° (Figure 8). During FY75, it was deployed at East Outer Channel LBI (Detroit), where it was exposed to thick and fast-moving ice. The buoy functioned well at this location except for one notable exception. In January 1975, the buoy was reported 1000 yards from charted position. The bottom is reported on charts and Simplified Aids-to-Navigation Data System (SANDS) reports as clay and soft, respectively. The anchor is assumed to have been silted in. The buoy deck was reported to be so covered with ice and snow that it caused the buoy to list approximately 80°. The light was approximately one foot from the ice. It is theorized that, with the buoy listing so badly, the large flat bottom presented a large area to the ice, allowing for high ice forces. The buoy may have been dragged across the anchor, causing the anchor to tumble out. At that time, the ice thickness was two to five inches with rafting up to two feet. The buoy was reset using the original 9000-pound STATO anchor and 12,750-pound concrete sinker plus a 10,000-pound ship's anchor. The original mooring had been in place from 22 December 1973 to 23 January 1975, although previous ice buoys had been attached to it.

Figure 8. 16-foot-diameter octagonal ice buoy with ice and snow on deck (Detour Reef Light Station - FY74)
